Coating Issues

Construction Issues

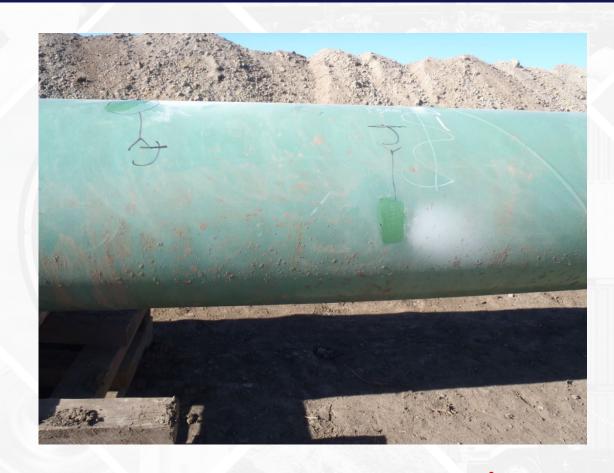
- Poor application practices
- Soil stress can remove poorly installed patch stick repairs
- Heating the patch stick and dripping the product on the coating holiday is not acceptable
- The photo shows a poorly adhered patch stick repair
 - This was found upon uncovering a newly built pipeline

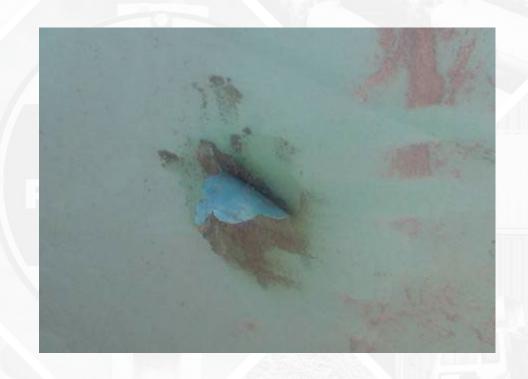
- Manufacturer's procedures for patch stick application must be followed
- The photo shows an applied patch stick repair scratched off by a fingernail

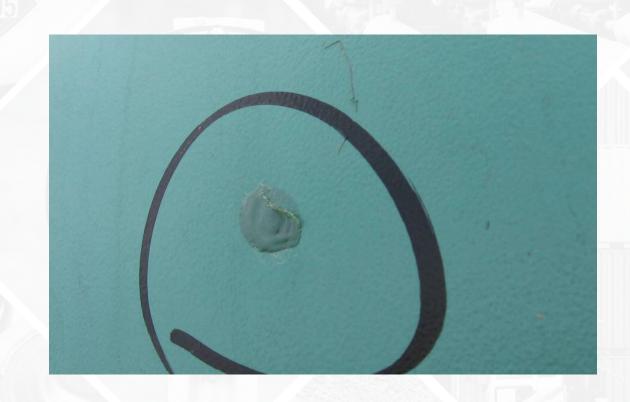
Good patch stick application

- Notice heated/discolored area around patch
- This indicates the pipe was heated before and during patch stick application

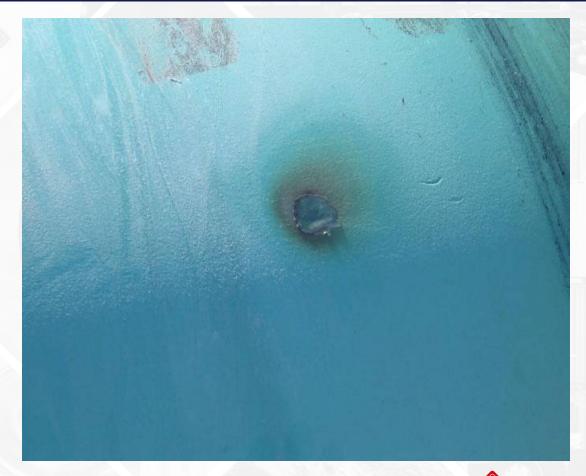
Only for Pinhole or Abrasion Repair

2-Part Epoxy Should Have Been Used

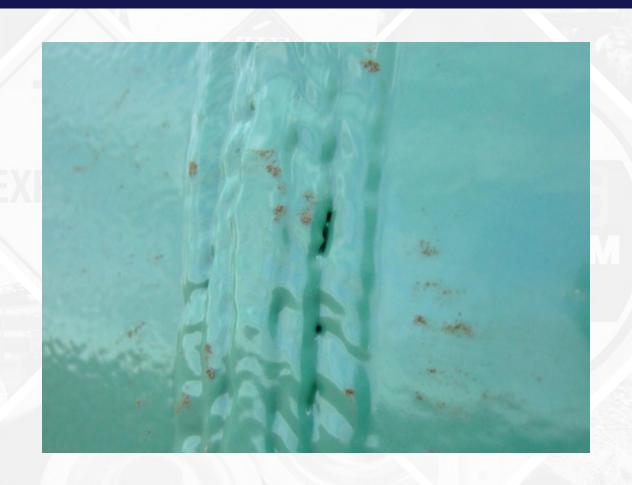
Damage by Welding or Beveling Band

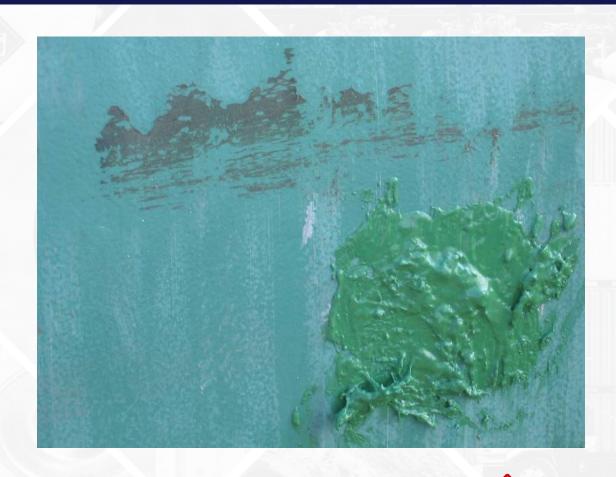
- Follow manufacturer's instructions
- Preparation required (Sanding = anchor pattern)
- Thoroughly mix product
- Use promptly
- If products start to cure before application, the repair presents the appearance of the next slide

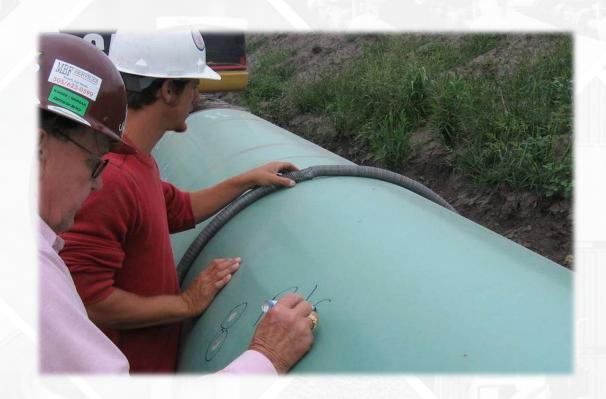
Bent Spring

A bent jeep spring can miss coating holidays

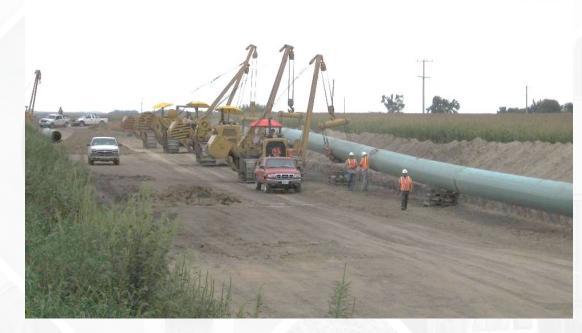
Jeeping Over Attachments

Manipulating the jeep spring over building fiberboard stuck to the pipe is poor practice

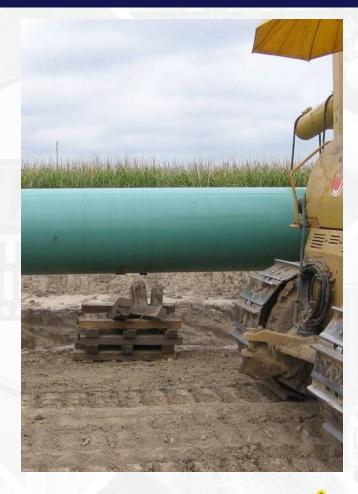
Jeeping at Skids

Jeeping at skids only on lowering in is not usually per construction procedures

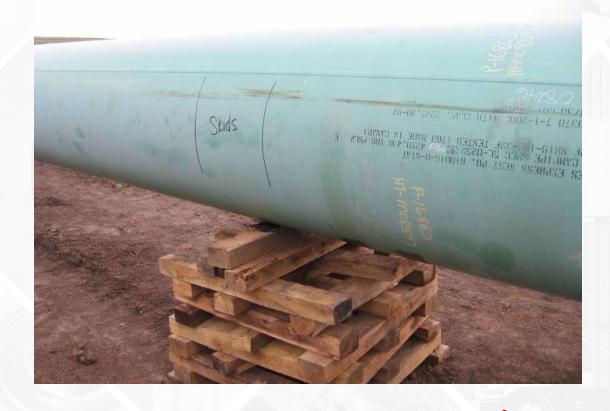
Duct Tape

Duct tape can shield coating holidays

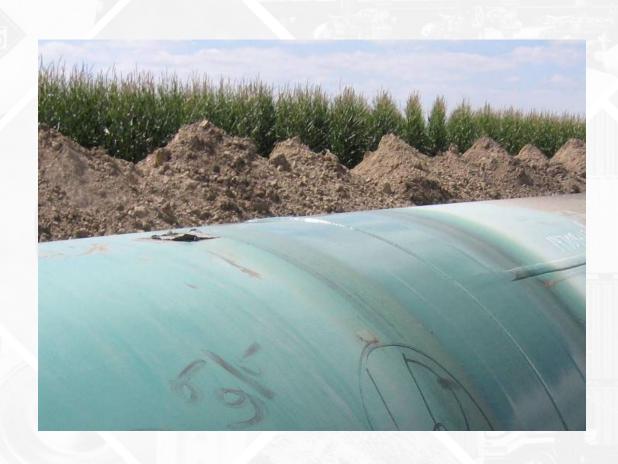
Damage Due to Poor Backfill Practices

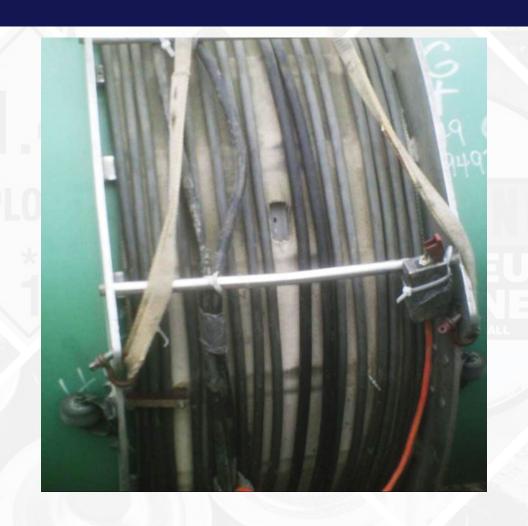
- Insufficient heating
 - 3M procedure specify $425^{\circ} 488^{\circ}$ F
 - Lower temperatures could mean improper curing
- Over heating during application can be a problem
 - Coating looks burnt and is unacceptable
- Poor sandblasting

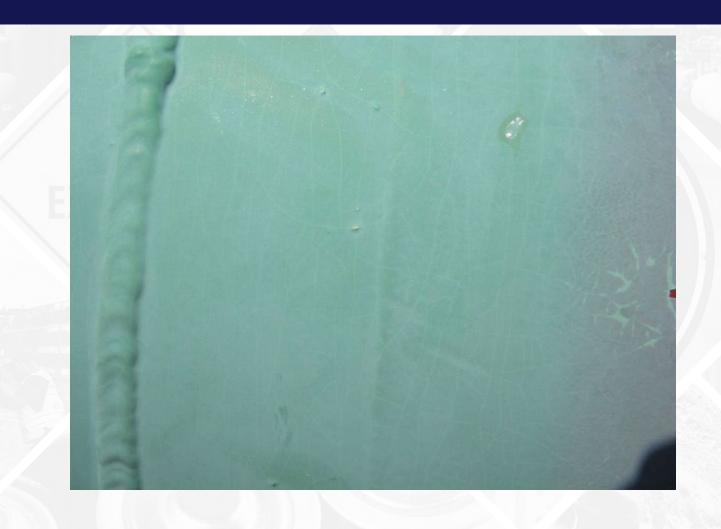
No Coating Coverage

Is there water in the pipe?

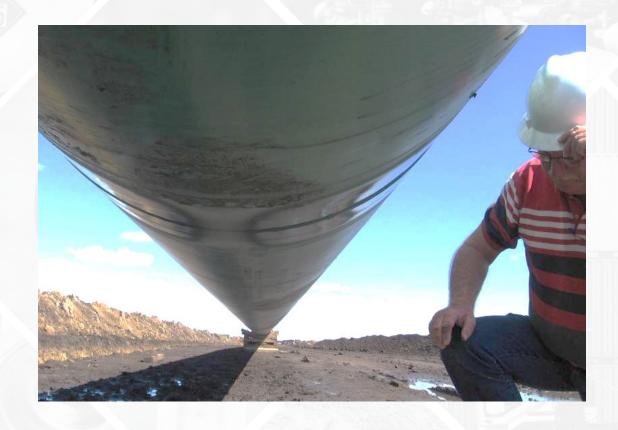
Gouges and Bending

- Consult procedures
- Acceptable wall thickness?
- < 1% diameter?

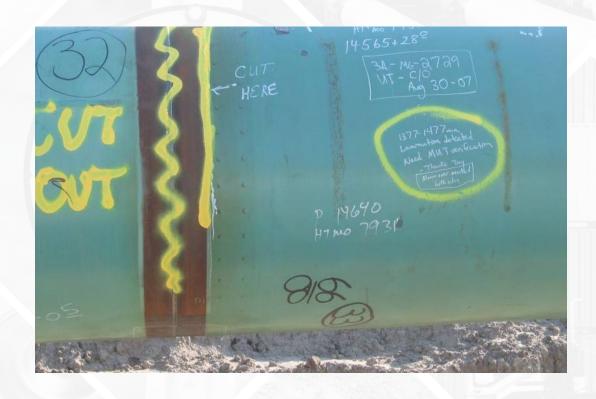
Laminations

Can be an issue especially associated with an 80% waiver

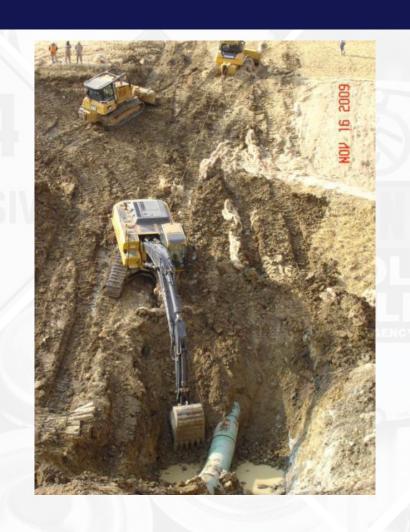
ADB-10-03 Girth Weld Quality Issues

- Misalignment
- Thickness transitions
- Welding practices
- Below in-service failure occurred at 65% SMYS

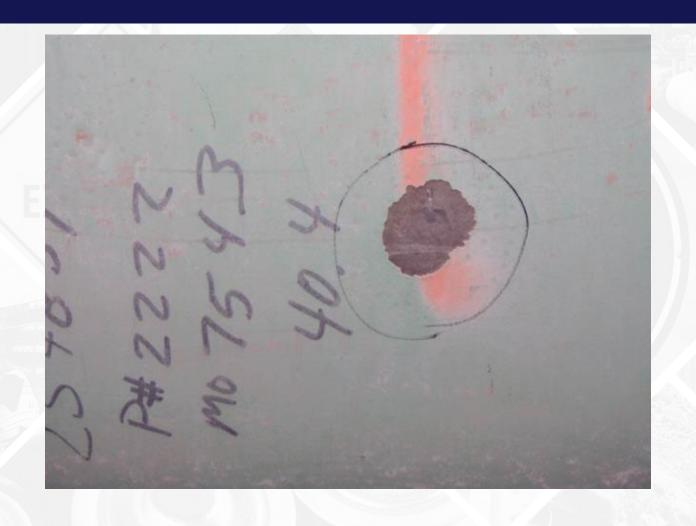
DCVG Dig on First Phase

Girth weld coating mixed with backfill

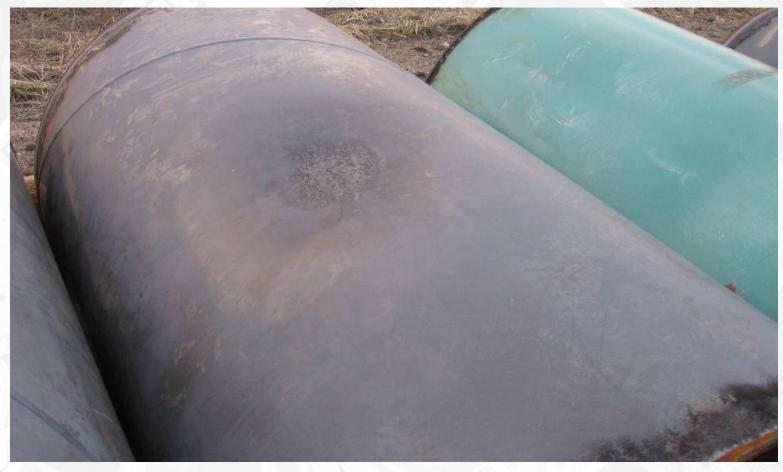
Pipe Defect

Does remaining wall thickness meet requirements of API 5L?

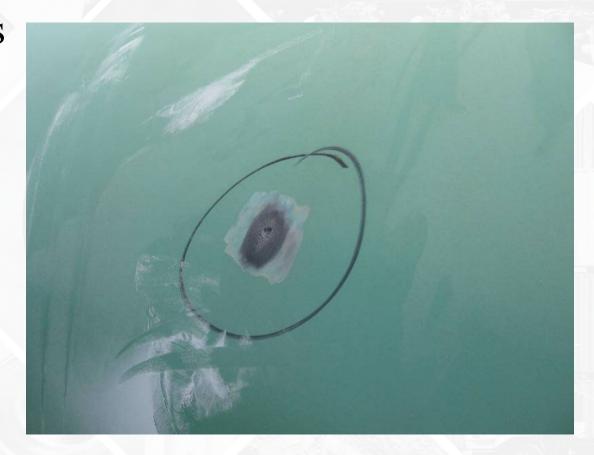
Grinding Remaining W.T.
