# **Innovative Methods for Assessing Non Piggable Pipelines**

## **Pigging the Un-Piggable**

September 11, 2013

# Pipetel

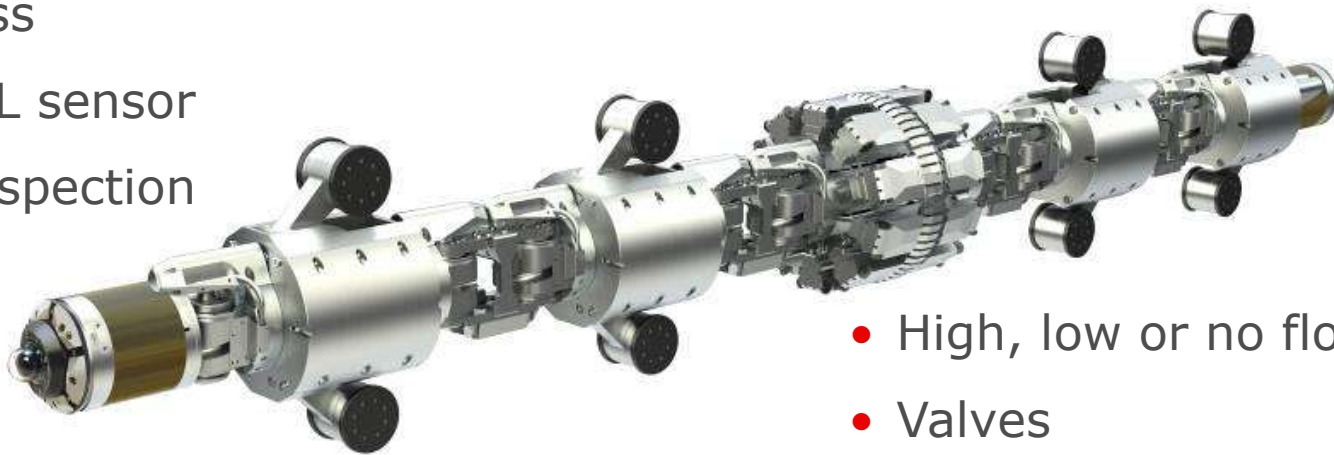
- Live pipelines up to 750 psi
- Self propelled
- Tetherless
- Axial MFL sensor
- Visual inspection

- High, low or no flow
- Valves
- Tees
- Bends
- Vertical segments

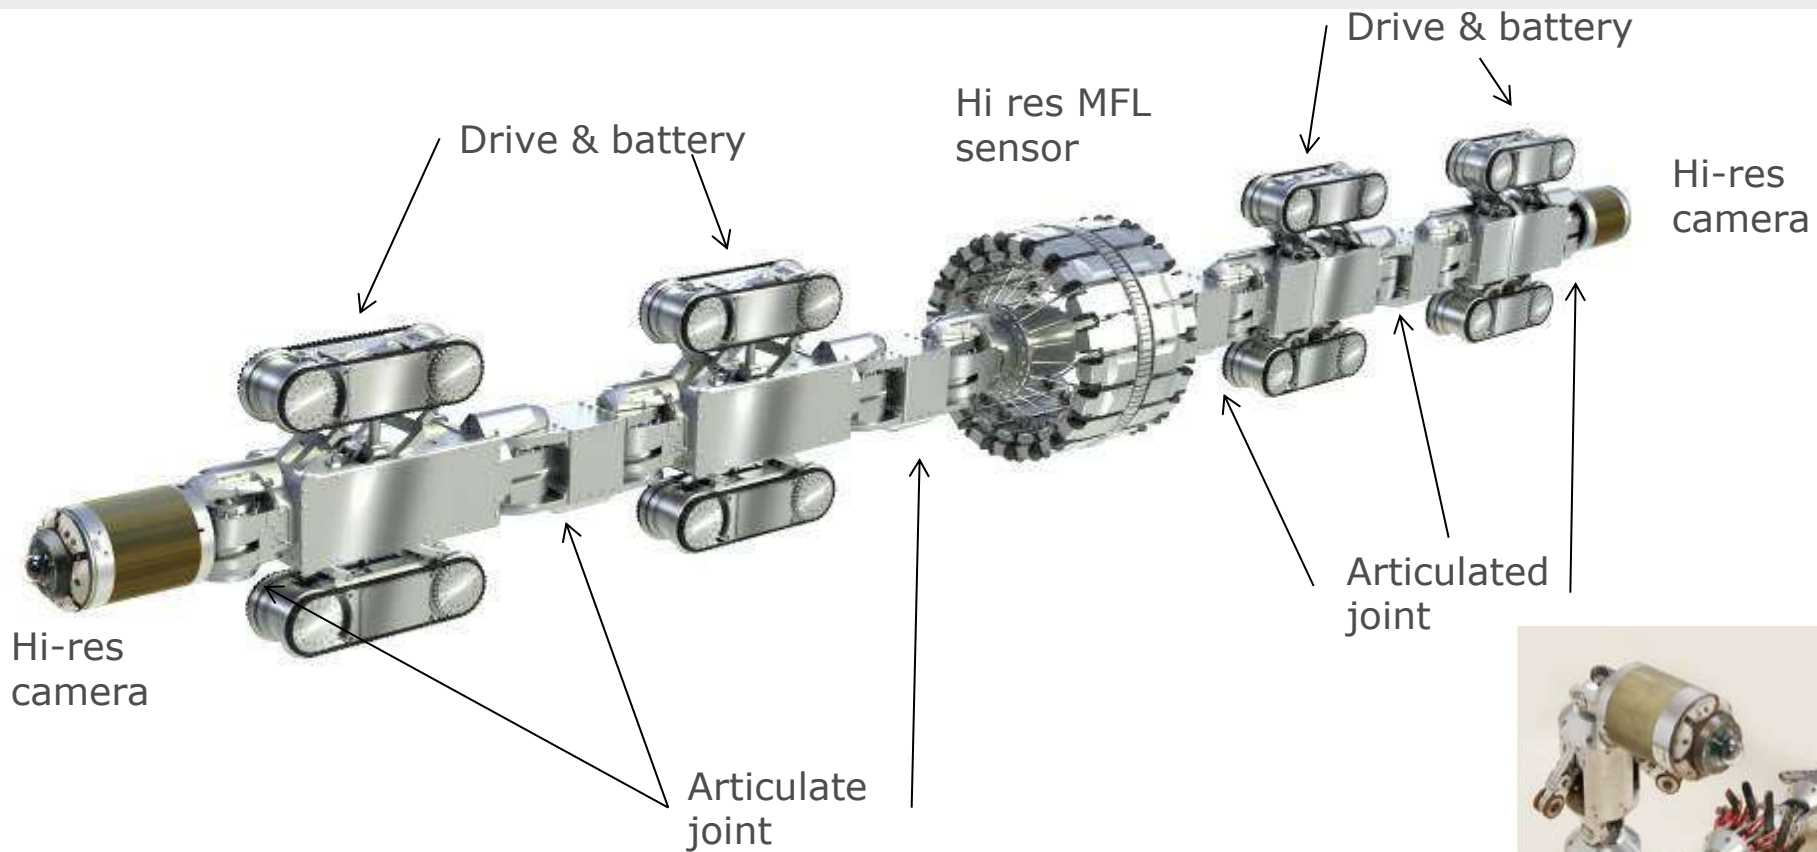
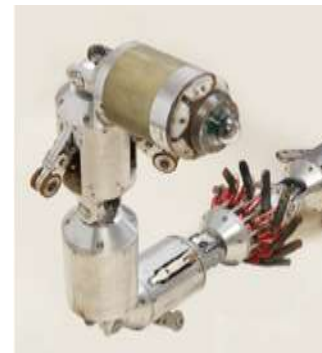
# Explorer

***EXPLORER 10/14***

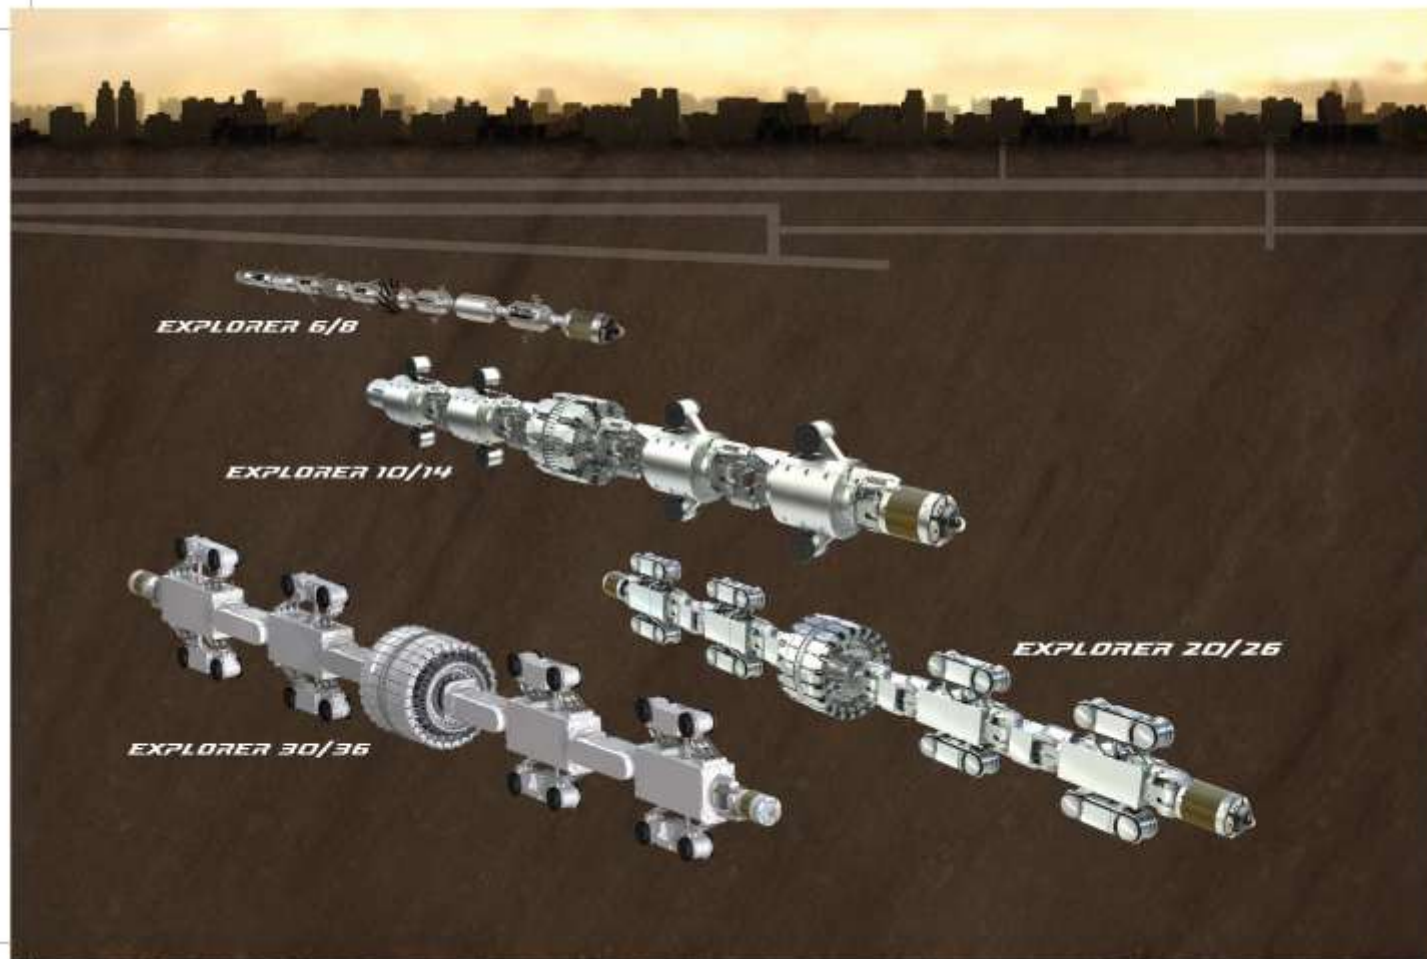
# Explorer Tools

- High Resolution Magnetic Flux Leakage (HRMFL)
  - Magnetizes the pipe and measures magnetic flux
- Remote Field Eddy Current (RFEC)
  - Transmits low frequency alternating current (AC) through the pipe wall
  - Ultrasonic testing (UT) technology without the use of a liquid slug

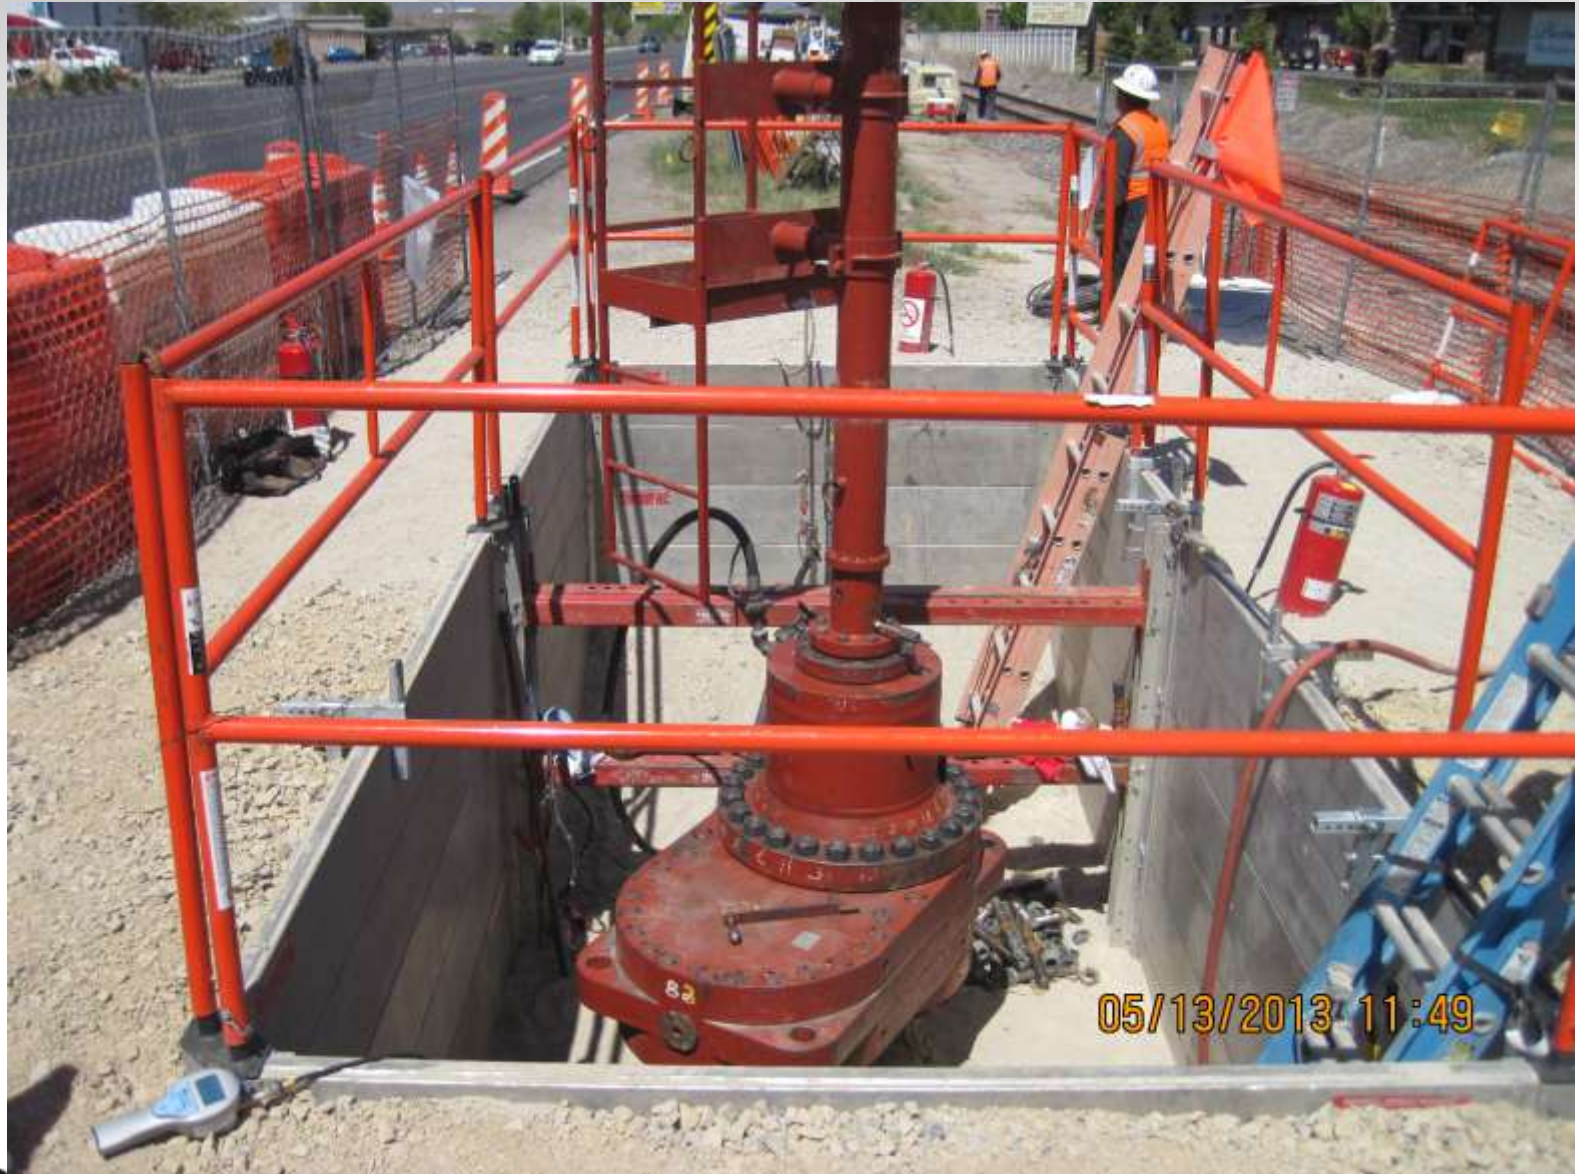
- Hot tapping of pipeline
- Installation of launcher/receiver
- Loading of Explorer inspection tool into launcher/receiver

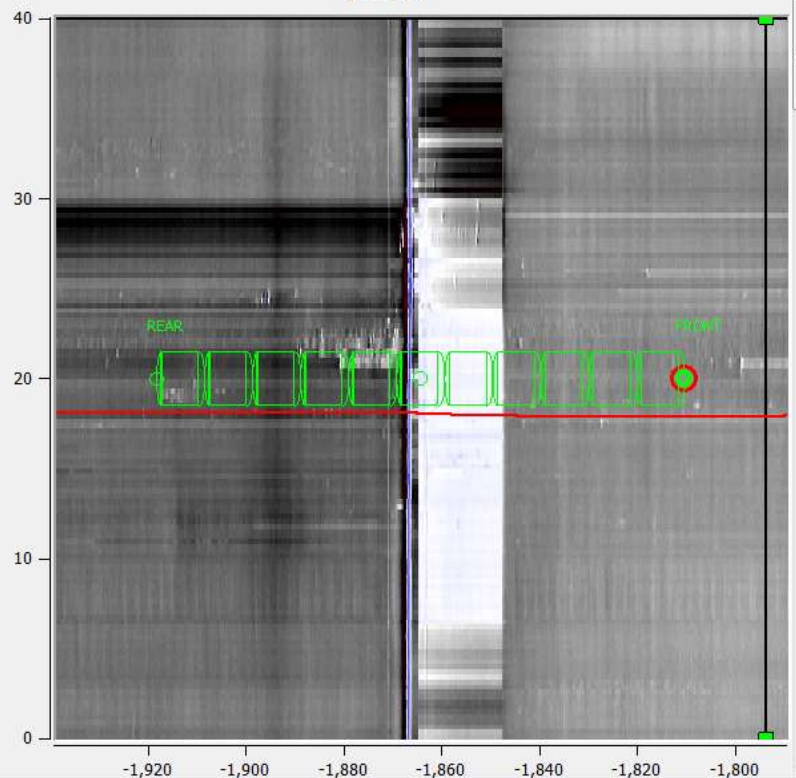
- Anomaly information
  - Type, stationing, orientation on pipe
  - Calculated safety factor
- Pipeline features
  - Measured casing length
  - Taps, tees, bends, etc.

Circ Distance (Inches)

Type	Sub-Type	Position	Angle Position	Length	Width	Depth
Feature	Installation	-2360.9	159	0	0	0
Weld	Weld	-1866.9				
Weld	Weld	-1216.1				
Feature	NA	-757.5	157	0	0	0

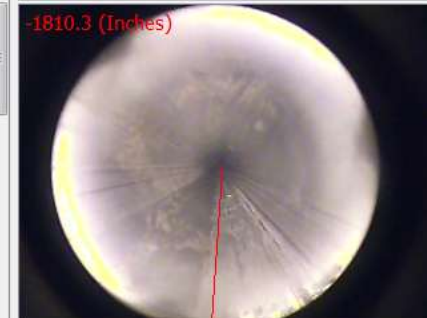
Video

- Internal video inspection
  - Identify location of dents
  - Unable to size dents
