Coating Issues

Construction Issues

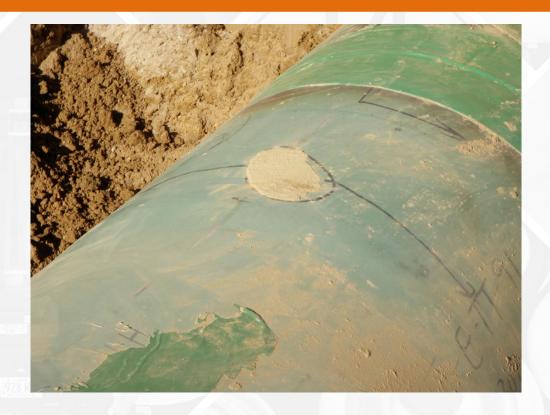
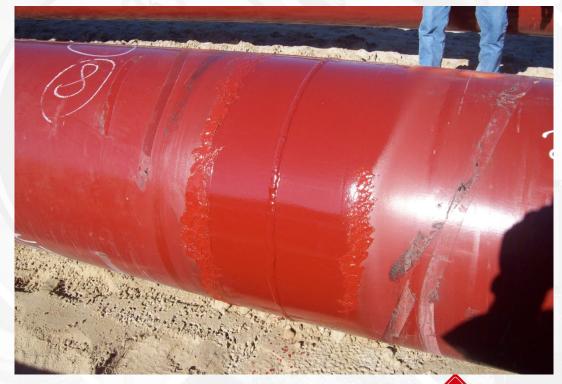
Coating Damage

Due to Pipe Support

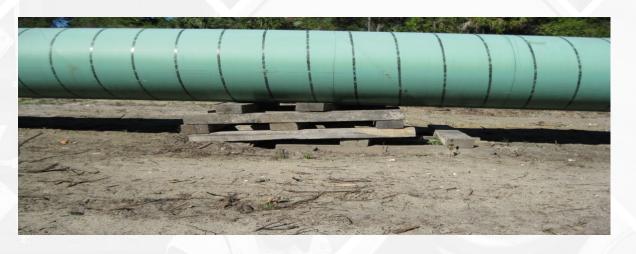
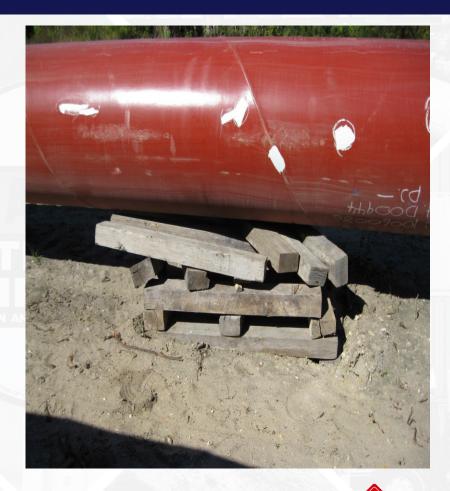
Coating Issues

Jeeping Over Soil

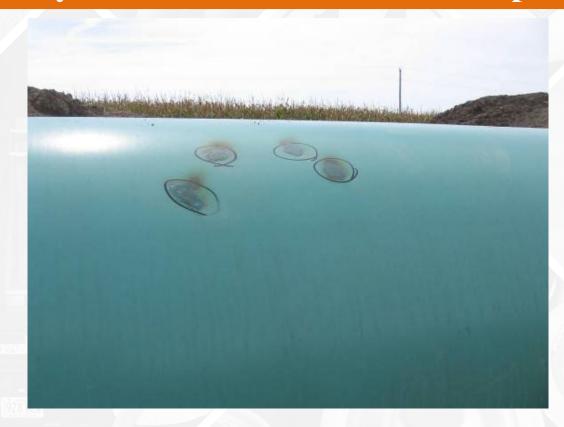
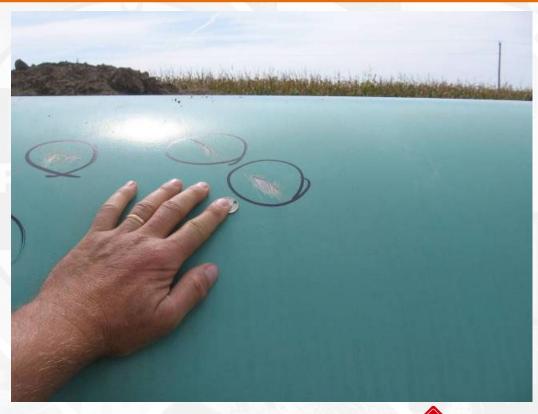
Only for Pinhole or Abrasion Repair

2-Part Epoxy Should Have Been Used

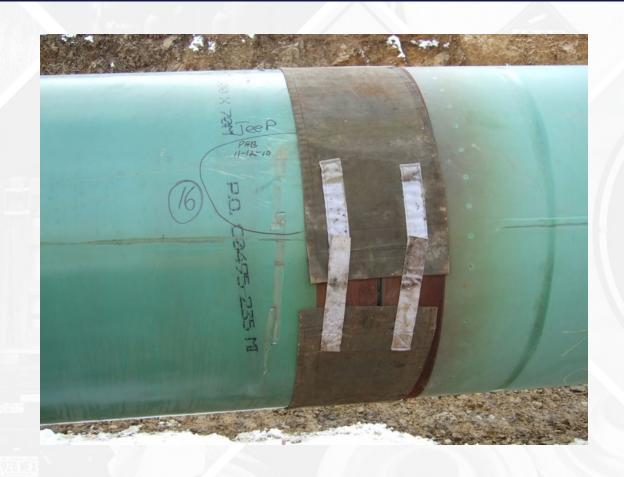
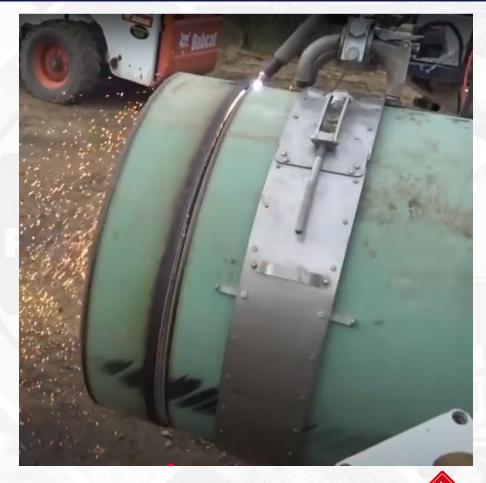
Damage by Welding or Beveling Band

- Follow manufacturer's instructions
- Preparation required (Sanding = anchor pattern)
- Thoroughly mix product
- Use promptly
- If products start to cure before application, the repair presents the appearance of the next slide

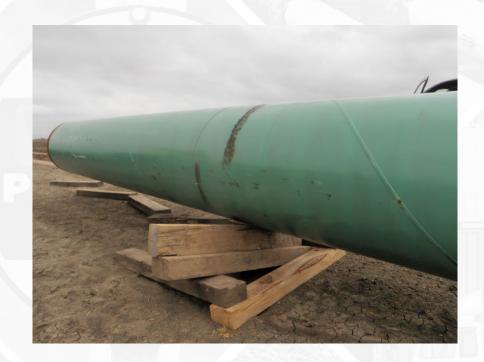
• 199 jeeps on section

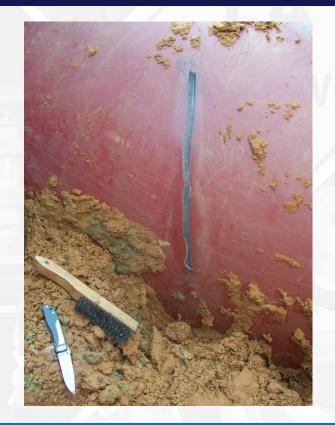
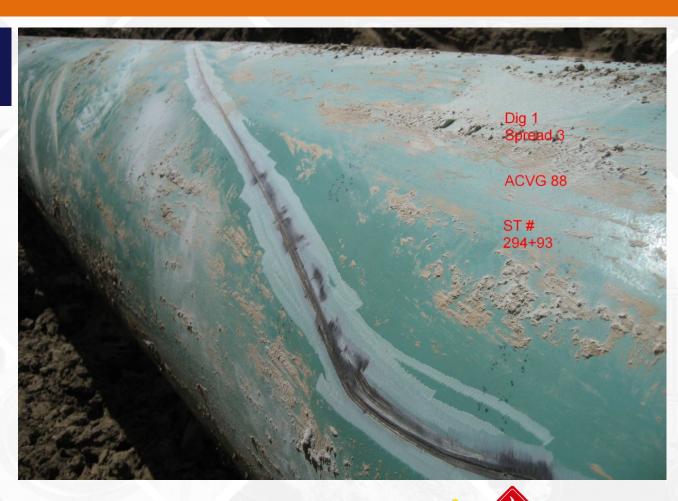
Damage Due to Poor Backfill Practices

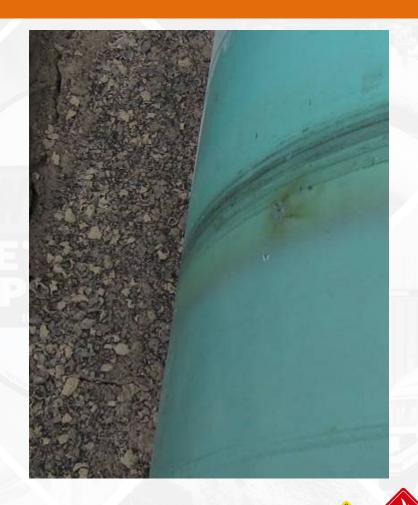
- Look for coating holidays in the ditch
- Observing these indicates a problem

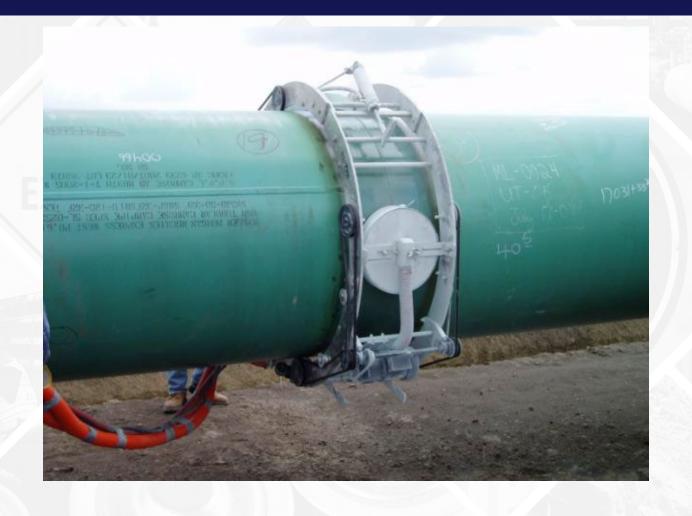
Girth Weld Coating

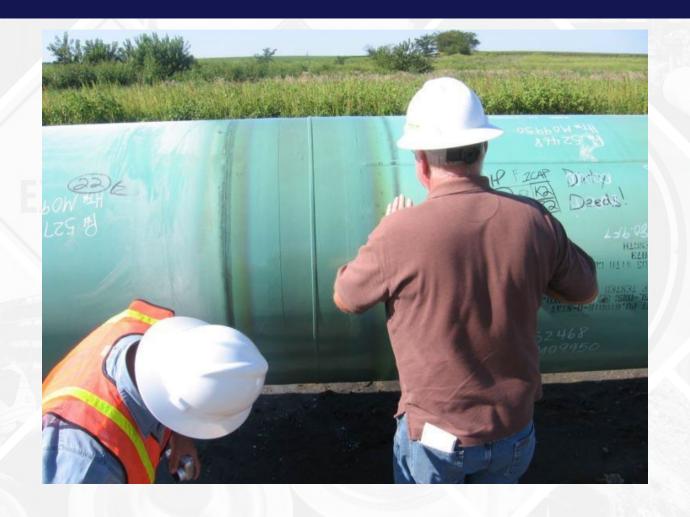
425°F to 488°F

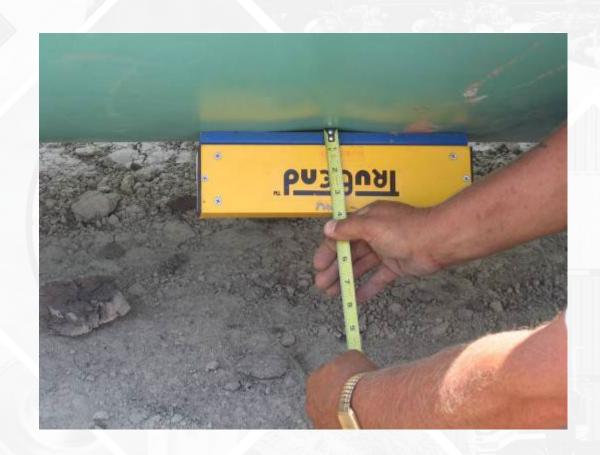
- Consult procedures
- Acceptable wall thickness?
- < 1% diameter?

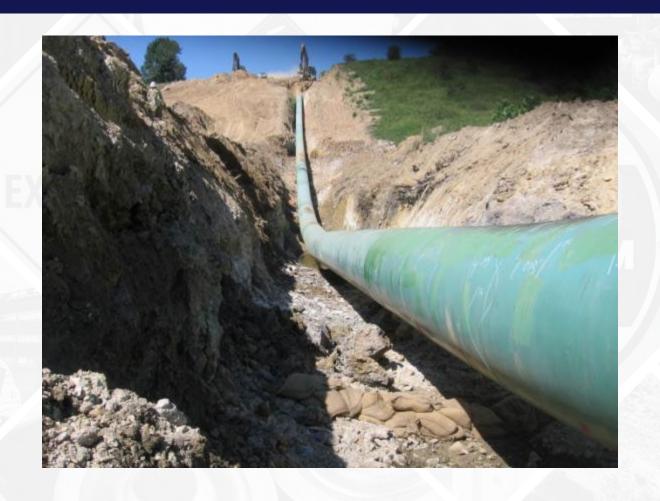
Rock Shield Needed

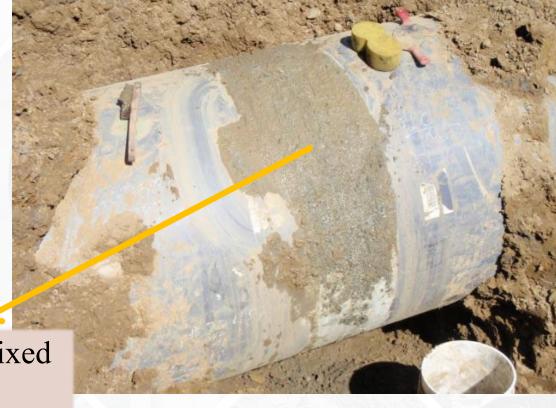
DCVG Dig on First Phase

Girth weld coating mixed with backfill

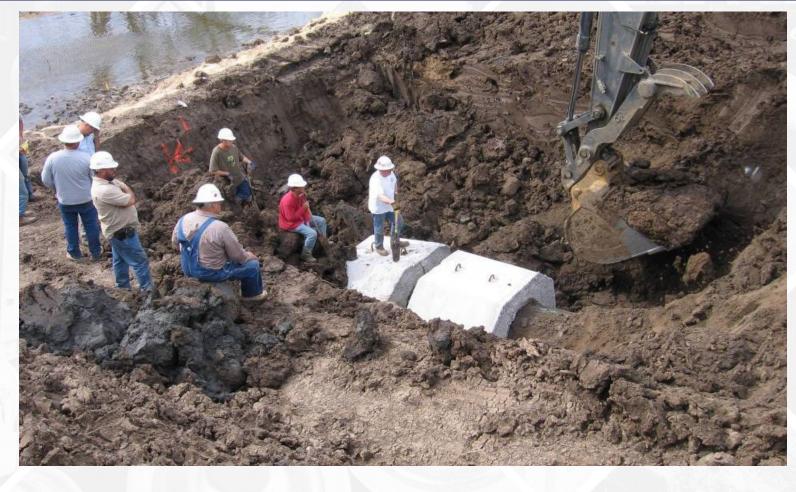
Are There Sufficient Weights?
